RENATURATION DU RUISSEAU DE SAINT-OUEN

Localisation : En amont de la rue Clément Ader et de l'étang communal.

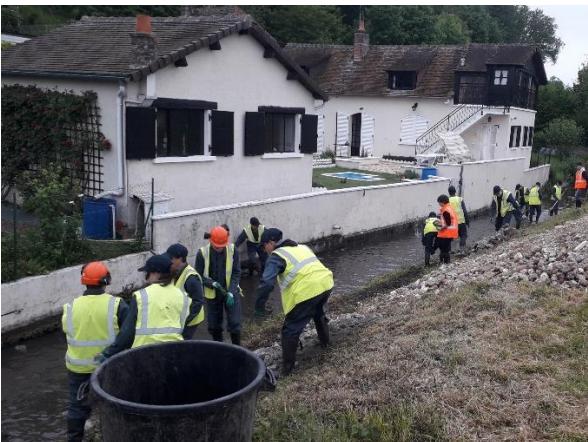
A group of construction workers wearing yellow vests and hard hats are gathered at the edge of a river. They appear to be preparing materials or equipment for the renovation work. In the background, there are houses and trees.

Le chantier s'est réalisé en partenariat avec le lycée agricole d'Areines-Vendôme, les élèves ont participé à la rédaction de la demande au titre de la loi sur l'eau ainsi qu'à la mise en place des pierres dans le cours d'eau.

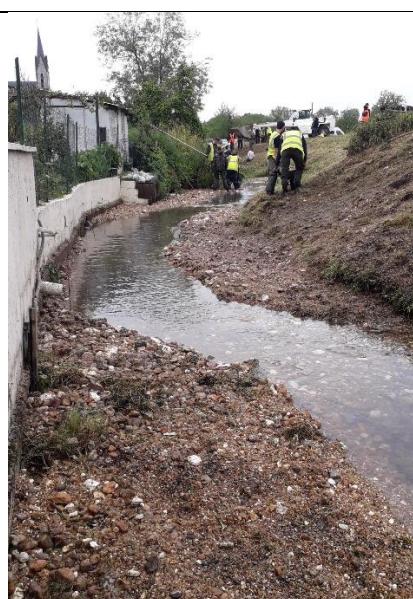
A view of the riverbed after the renovation. The channel has been narrowed and deepened, with a bed of stones and gravel. The water is flowing more rapidly than before. Some workers are visible in the background near the newly constructed bank.
Tronçon amont avant travaux	Tronçon amont après travaux

Présentation des bénéfices observés : Le cours d'eau présente maintenant différents faciès d'écoulements, des zones rapides et d'autres plus lentes. On peut observer la présence de différents poissons.
