AMENAGEMENT DE PASSAGE A GUE SUR LE REVEILLON

Localisation : Lieux-dits la Grapperie, les Dérompées et le Cloary, communes de Meslay et Saint-Firmin-des-Près

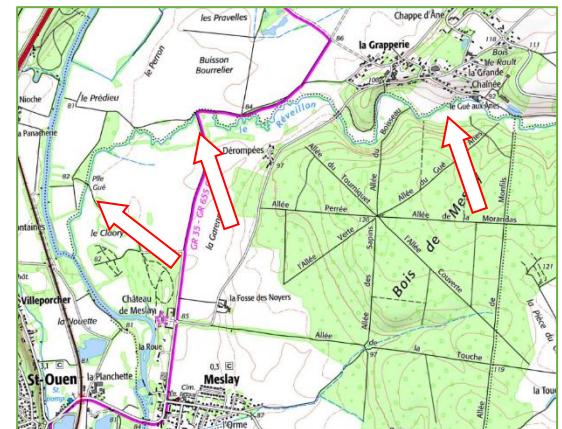
Problématique des sites : Les passages à gués sur le Réveillon présentaient des sur-largeurs pour deux sites, occasionnant un réchauffement de l'eau et l'absence d'empierrement pour un site, entraînant l'érosion du fond de la rivière et la mise en suspension de particules fines (terre et vase).

A photograph showing a small, stagnant pond or a section of a river before the work began. The water is dark and reflects the surrounding dense green vegetation.	A photograph showing the same area after the work has been completed. The water is flowing more freely through a cleared path, and a bright orange excavator is visible on the right side of the frame, indicating the completion of the stabilization work.
Photo avant travaux	Photo après travaux

Apport et mise en place d'un mélange de pierres et graviers pour stabiliser les passages et réduire la stagnation de l'eau.

Présentation des effets observés : L'empierrement des passages à gués a évité l'érosion du fond de la rivière et amélioré la qualité de l'eau (réchauffement et la turbidité)
